Into the Abyss: The Case of the Collapsing Sinkhole

Department of Geography/Geology
University of Wisconsin—Stevens Point

Part I—Sinkholes Near Orlando, Florida

Part II—Mining Company Sued for Causing Sinkhole

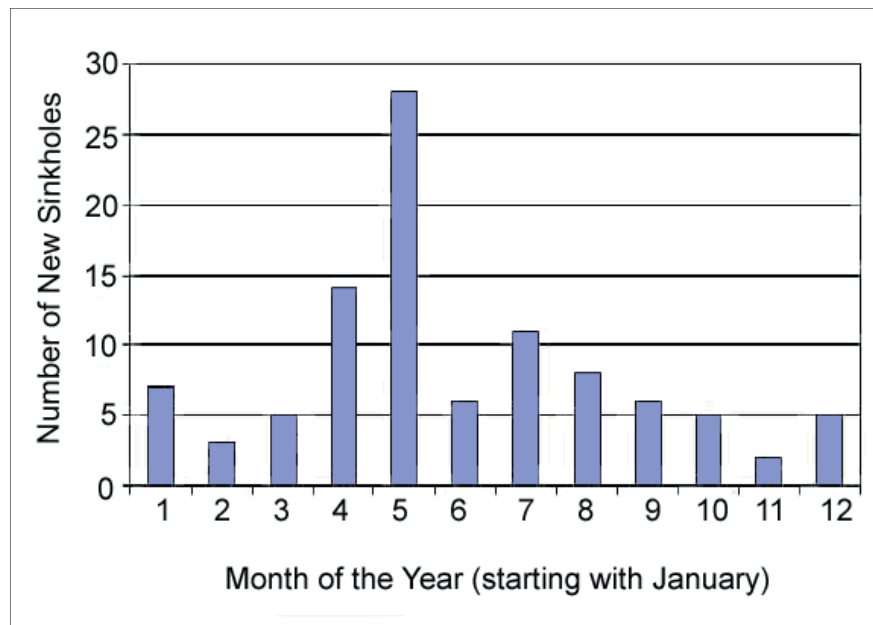
Figure 2: Number of new sinkholes in Orange and Seminole Counties, Florida by month of the year for the years 1961 through 1986. Note that the month of the year is represented with a number, starting with January as 1 and ending with December as 12.

At least 140 new sinkholes formed in the Orlando area (Orange and Seminole Counties) between 1961 and 1986, with an average of 11 new sinkholes appearing each year (Wilson and Beck 1992). Data from Wilson and Beck (1992) show that the appearance of new sinkholes is not equally distributed throughout the year (see Figure 2).
